## SELECTED CASE: AGING PIPELINE

## PROBLEMS & SOLUTIONS

### REDUCING THE RISK OF ELECTRICAL ARCING

**California State Lands Commission  
Marine Facilities Division  
200 Oceangate, Suite 900  
Long Beach, CA 90802  
(562) 499-6312**

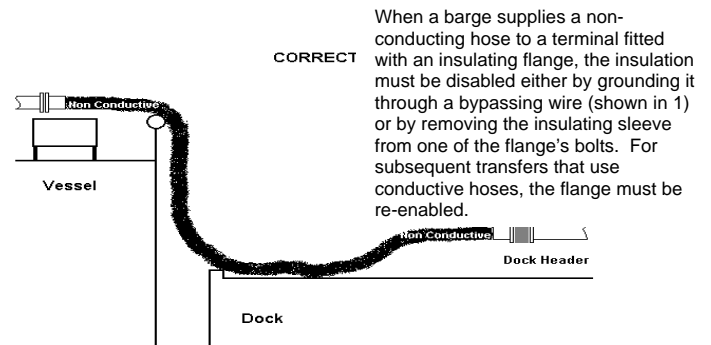
Figure 2

not re-enabled when a conducting hose is used in a subsequent transfer (Figure 2).

In the latter pattern, a **substandard condition of the operator** (lack of knowledge) triggers a **decision error** of connecting hoses without regard to proper insulation and grounding. *This could be addressed by providing training, rather than a DOI reminder, that describes the risk of electrical arcing and relates it to specific equipment, vessels, and transfers at the facility in question.*

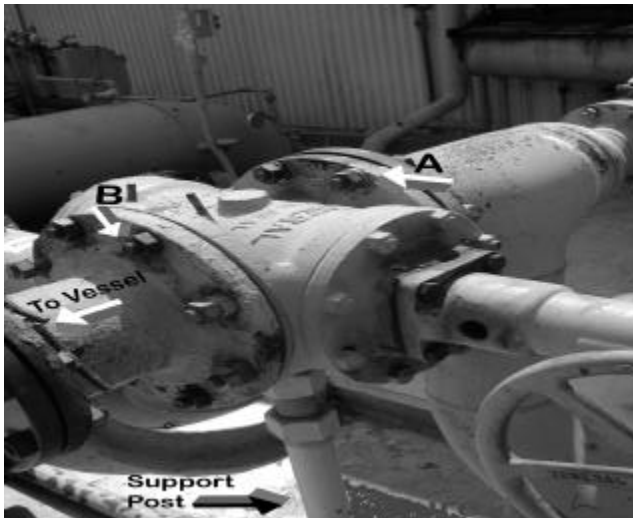
An insulation sleeve is incorrectly positioned at location A. Because the support post touches the dock, there is electrical continuity between the terminal and vessel, which introduces a risk of electrical arcing. Moving the sleeve from point A to point B would electrically isolate terminal and vessel, resolving the problem.

placed (see photo) or the vessel side of a transfer hose touching the dock (Figure 1); or (2) non-conducting hoses being supplied by a barge and a terminal-side insulating flange is not disabled, or is

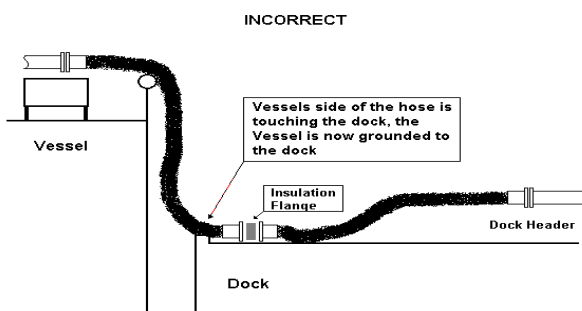
Figure 1

Regulations require that all metal on the vessel's side of a transfer connection be electrically continuous with the vessel and that all metal on the terminal's side be continuous to the terminal's grounding system. Terminal and vessel sides must also be electrically isolated from each other either through the use of an insulating flange joint or a single length of non-conducting hose, in order to mitigate the risk of electrical arcing and the potential for ignition of transferred products. State Lands Inspectors have often encountered connections that do not meet the requirements described above, including: (1) improper grounding, due to either insulating flange kits being improperly

The former pattern represents a case in which a **substandard practice of operators** (poor communication during briefing) triggers a **skill-based error** of forgetting a step in a procedure. *This could be addressed by incorporating specific items into the Declaration of Inspection (DOI) that reminds operators to: (1) identify the types of hoses that will be used in the transfer; and (2) check the status of insulating flanges and ground connections.*
